# ARKENDALE, THE MAR

## HYDROLOGICAL REPORT

AUGUST 2017

Project No: 70023730  
Date: August 2017

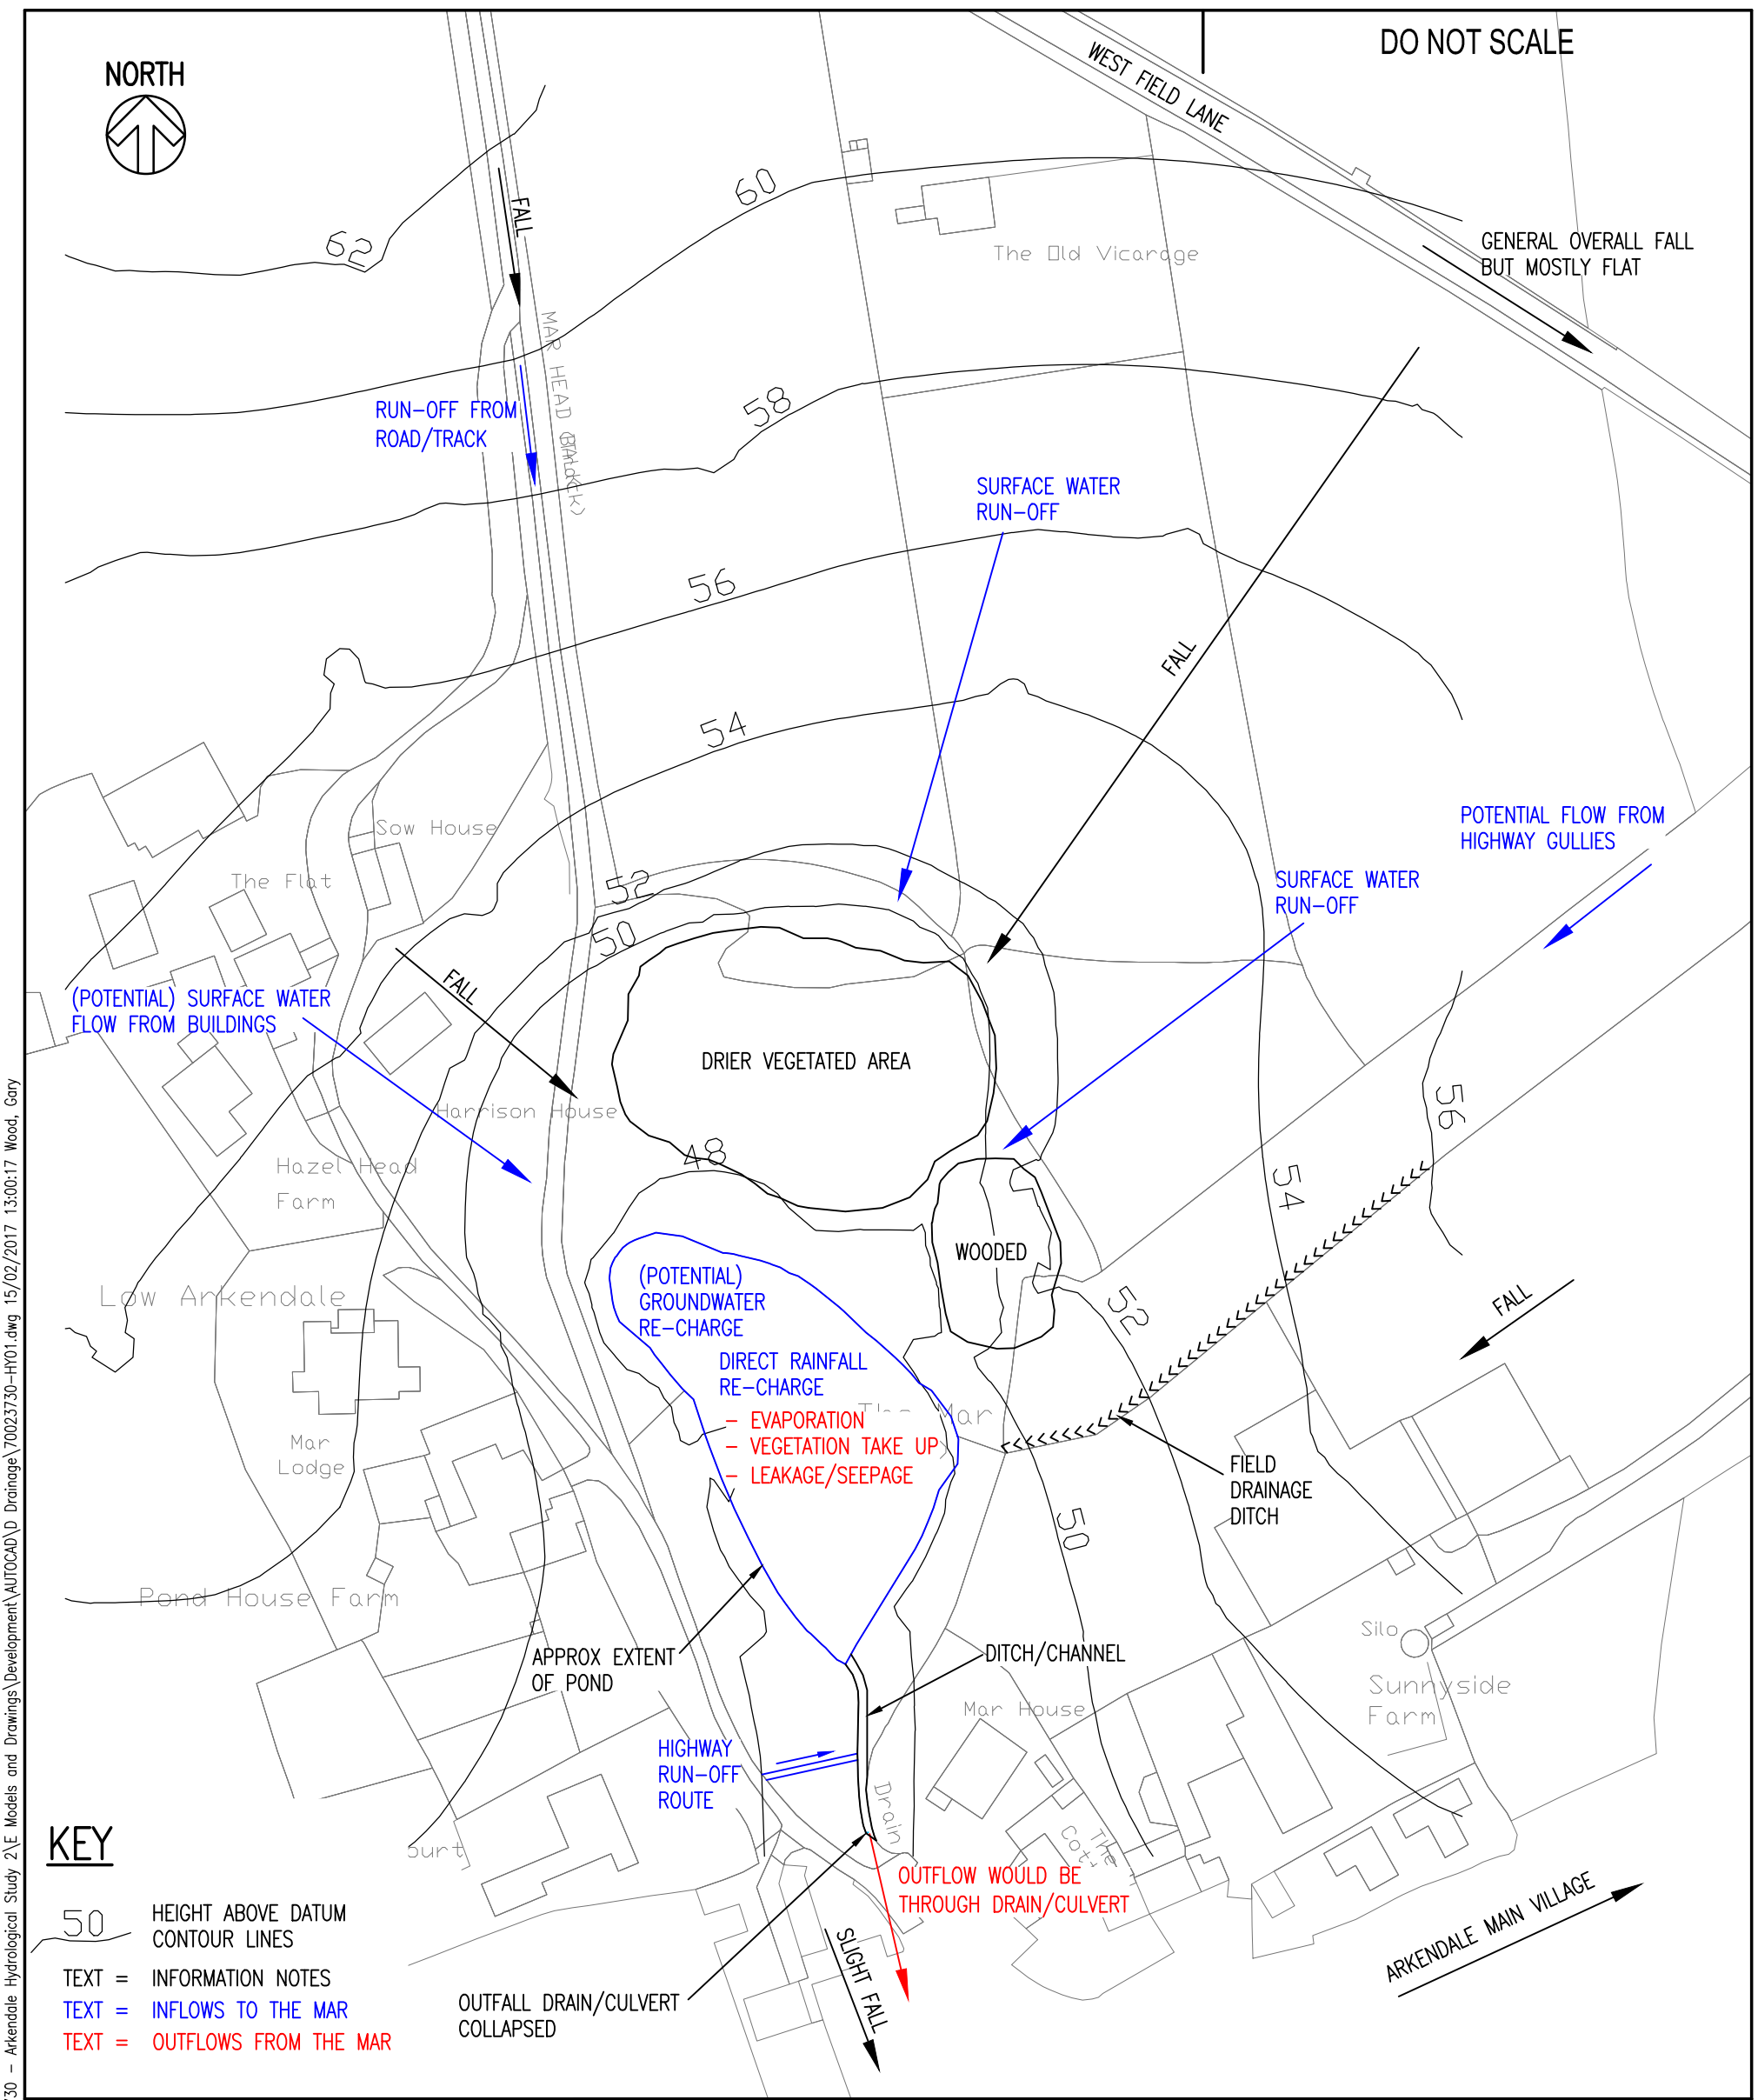
**CONCEPTUAL INFLOWS AND OUTFLOWS TO THE MAR**

2.1.3 This Hydrological Report summarises the main findings of the assessment undertaken and includes a summary of the data used to analyse the site. An annotated conceptual plan of the site has been produced for clarity and ease of reference, which summarises the hydrological characteristics of note and is included in this report in Appendix A.

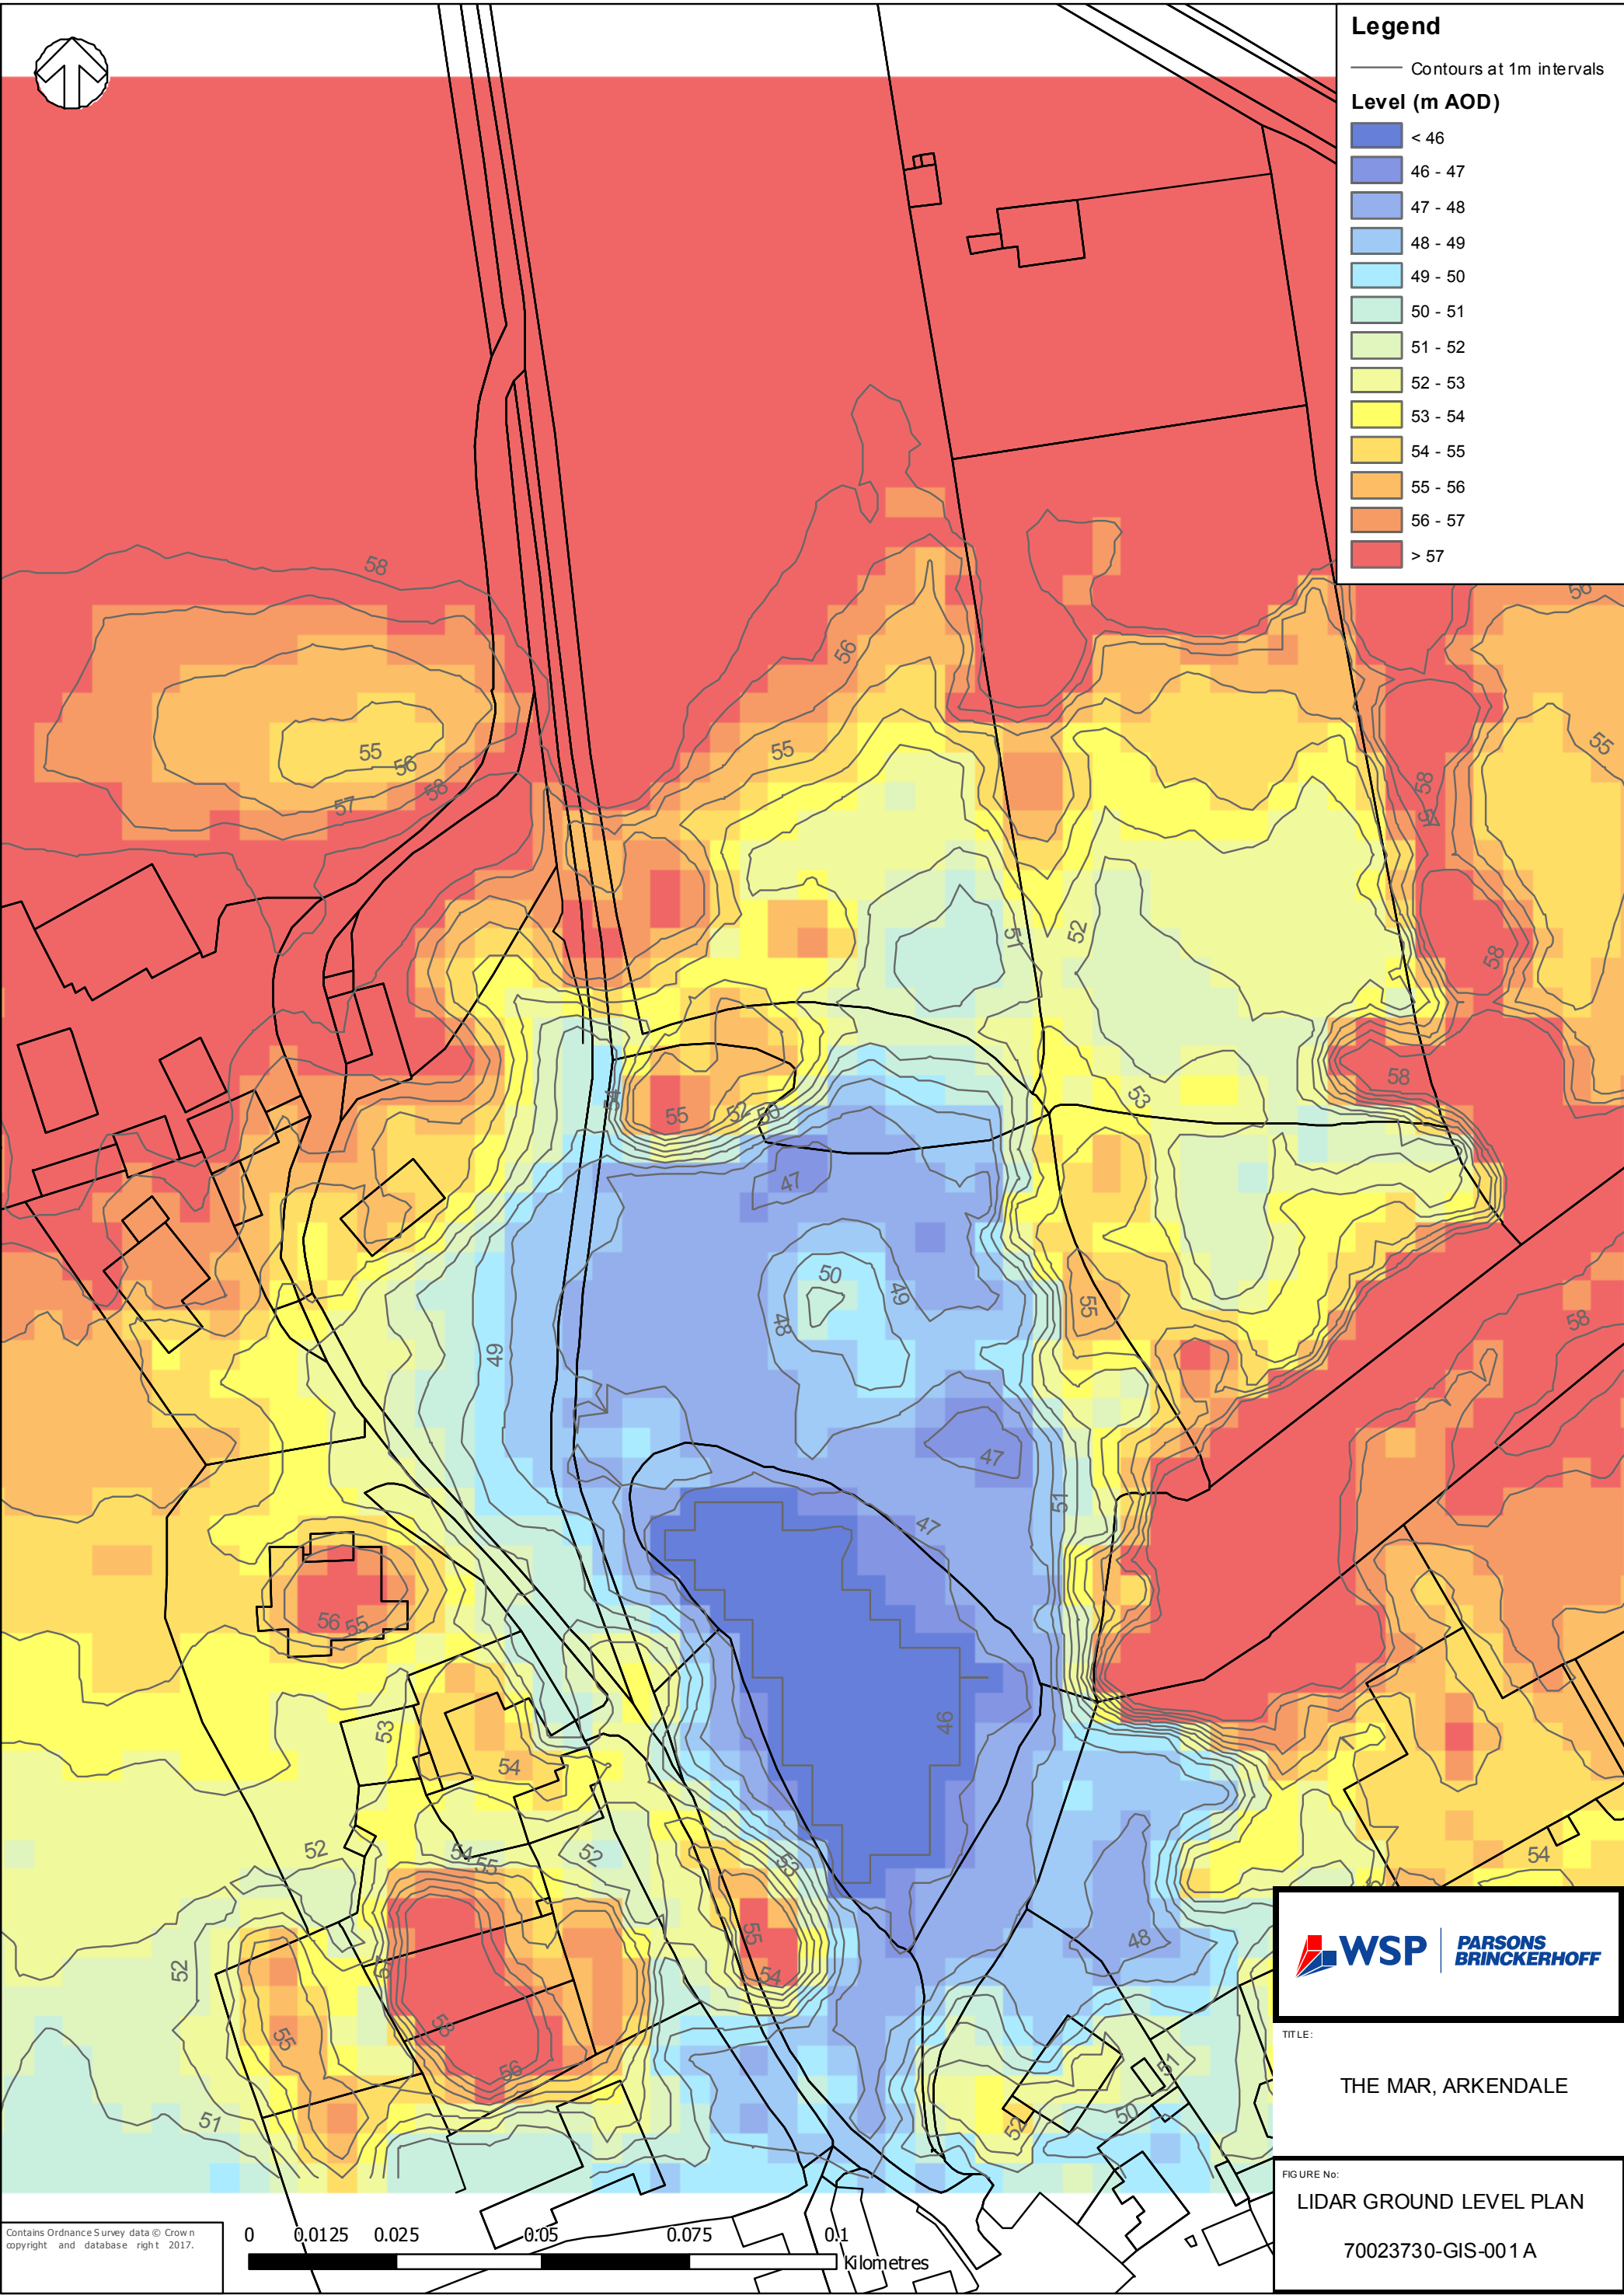
**LIDAR GROUND LEVEL PLAN**

- 3.7.1 Detailed ground level information was obtained in close proximity to the site to better understand existing levels surrounding the site. This data has been overlaid upon a simplified background map for the site to enable a profile of the topography of the site to be developed, which is recorded in the LIDAR Ground Level Plan (Drawing 70023730-GIS-001A Appendix C)<sup>7</sup>.

- 3.7.2 The LIDAR ground plan indicates that the current position of the water body within the pond site area occupies the principle lowest point on the site, which is to be expected. The small variance in ground levels within the site indicates that deeper water levels would likely extend the footprint of the pond considerably providing the appearance of a larger pond albeit at shallow depths.

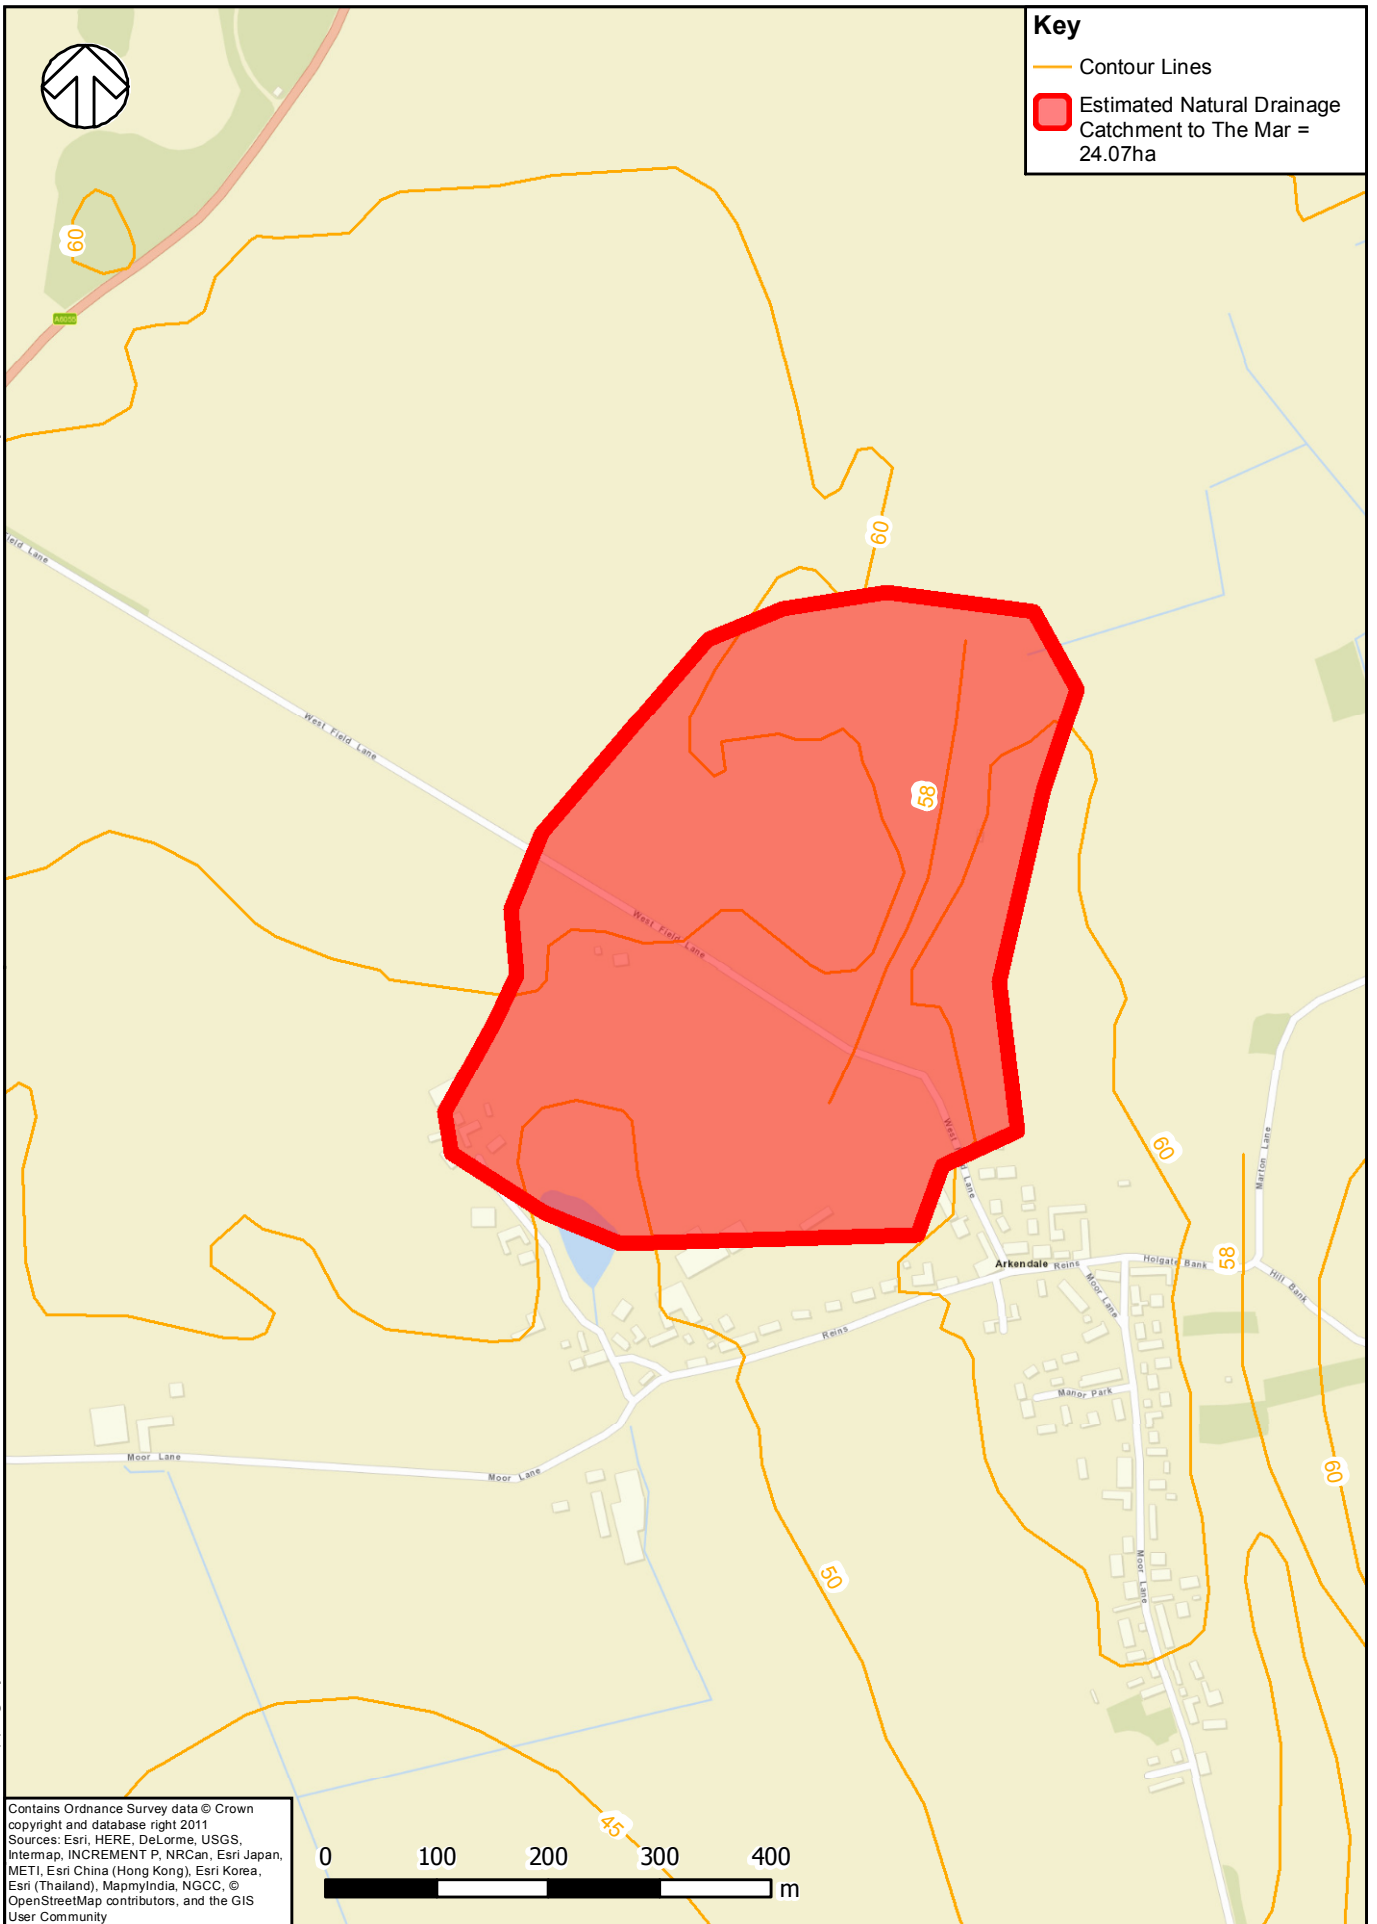
**ESTIMATED HYDROLOGICAL CATCHMENT OF THE MAR**

- 4.1.2 A review of the likely drainage catchment for the pond based on wide scale topography has been completed, a copy of which can be seen in Appendix D. This assessment, considered that approximately 24 hectares of area could drain to the pond, which when assessed using industry standard run-off calculations would generate surface water run-off in a storm of a one year return period, towards the pond of approximately 91 l/s at its peak.

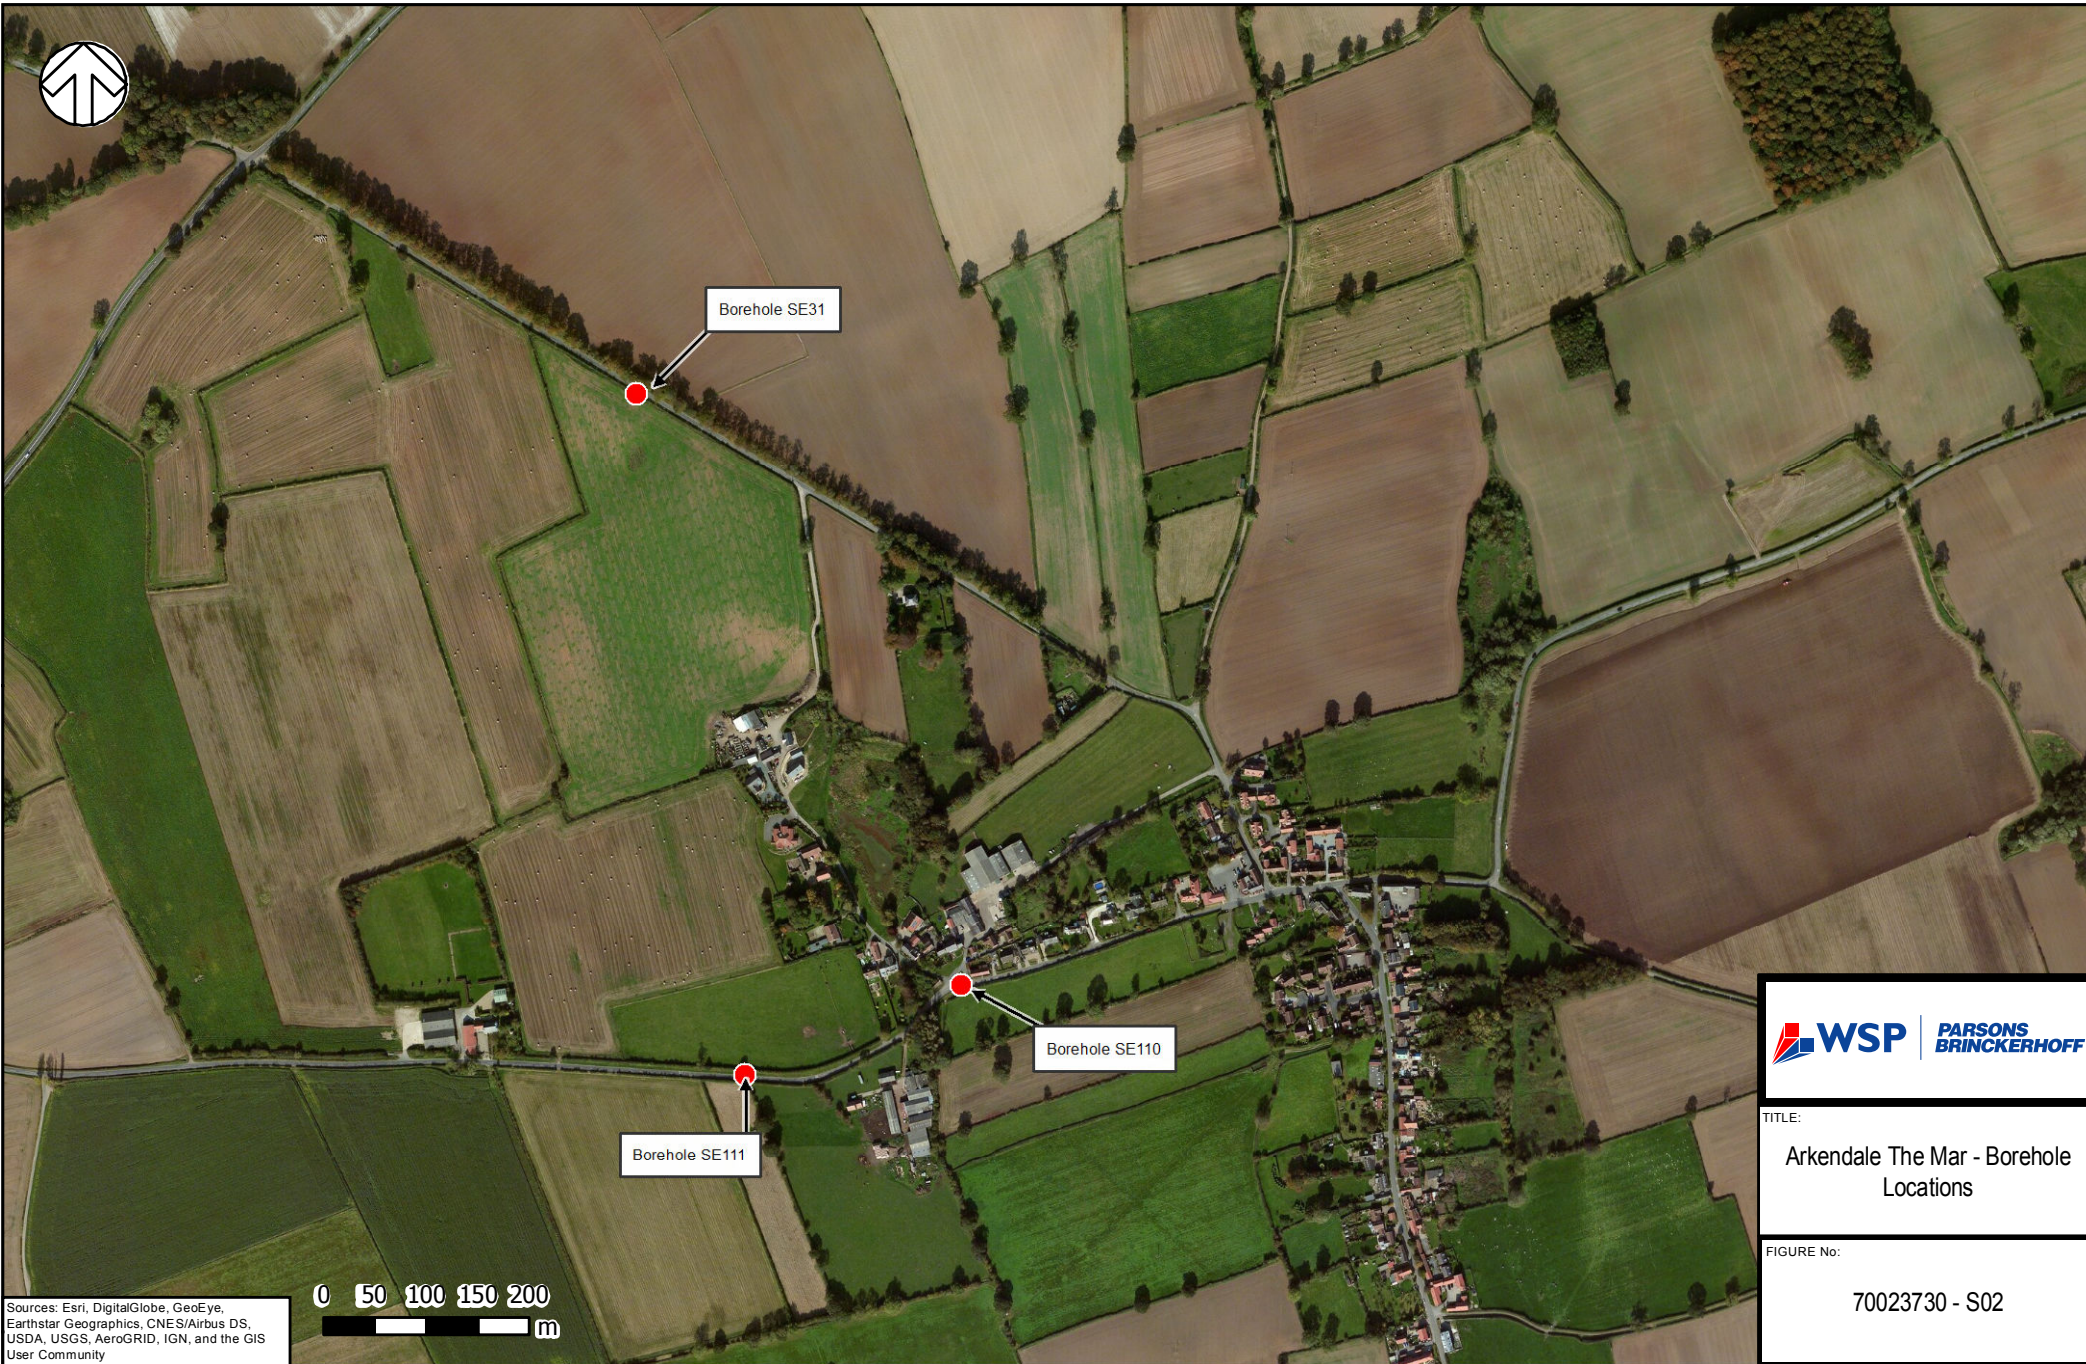
**BOREHOLE LOCATIONS**

- 3.4.1 A review of the BGS Borehole records, indicate that there are three boreholes recorded in close vicinity to the site. Refer to drawing 70023730-S02 (Appendix E) for locations of boreholes
